# Rehab Technology Summit

On  
Inspection  
Assessment  
Condition Survey  
Repair & Rehabilitation  
Retrofitting and  
Protection of Concrete  
Bridges & Buildings

## INTEGRAL & SURFACE PERMEABILITY REDUCERS & ELIMINATORS- PRODUCT SELECTION CRITERIA

transactions on: REPAIR RESTORATION RENEWAL OF BUILT ENVIRONMENT

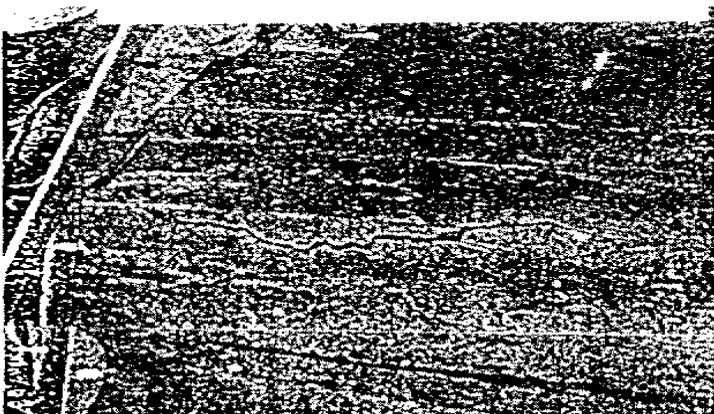
Flakiness index, elongation index & sediment residues( as per IS 2386 part 2 -1963 ) of aggregates from quarries play major role in concrete mix design. In spite taking all factors pertaining to coarse & fine aggregates in to consideration, porosity still prevail in concrete more or les, most of the time indispensable. The reason being sizes & shape of natural aggregates being natural & hardly much can be done about it Except taking due care in terms of their proportions in concrete matrix. Large difference in particle size distribution resulting due to availability of

reduced particle size of higher grade cement create what is known as particle size interference. Gap graded concrete in spite all claims have not proved to be as effective as continuously graded concrete. No concrete with zero permeability could be achieved without voids / capillaries.

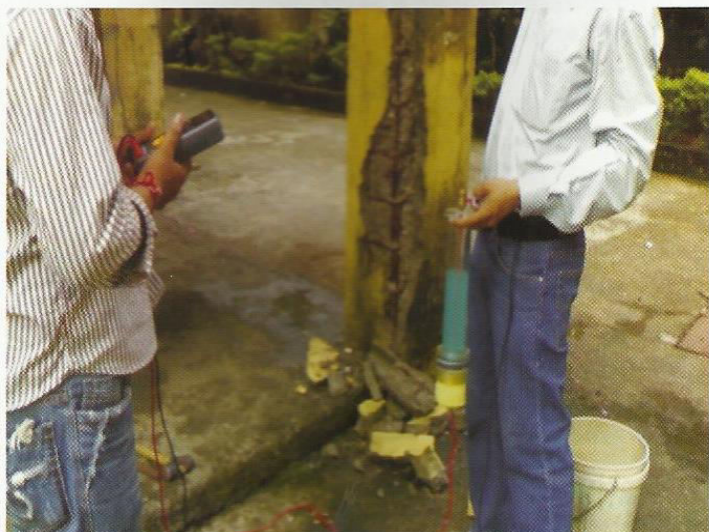
reinforcement steel to measure the potential difference between steel and the standard reference electrode of Cu /CuSO<sub>4</sub> in contact with the concrete surface (Figure 4).

**Figure 4.** Testing on reinforcement steel to know extent of corrosion and rebar continuity by Half-cell Potential Meter

In all those cases half-cell potential readings were tested between - 400 mV to - 500 mV indicating the high corrosion risk as per ASTM C 876 which gives guidance for corrosion activity in the concrete as given in Table 3.

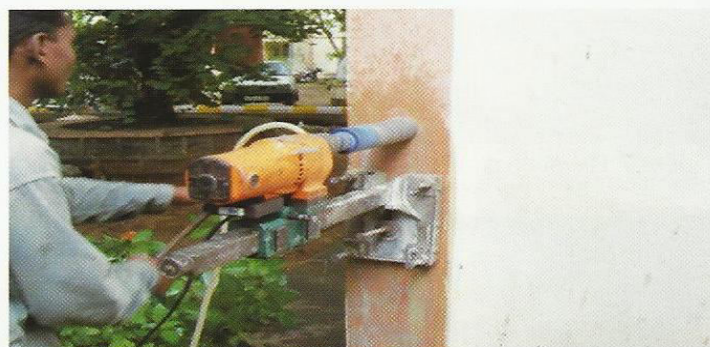
**Figure 5.** Core cutting of concrete to test chemical properties and compressive strength at lab

Cover meter was used to measure the thickness of the cover concrete. Some core samples were taken from columns for measuring in-situ compressive strength and chemical analysis in the laboratory for measuring the ingress of chloride ions and carbonation. The cores were drilled (Figure 5) and samples were taken to laboratory and suitably capped at both ends and tested in compressive strength testing machine. The suitable correction factor was applied to assess the probable compressive strength. The test results were in conformity with Rebound Hammer and UPV tests. This established the damages in those nine columns due to severe corrosion and followed by development of cracks

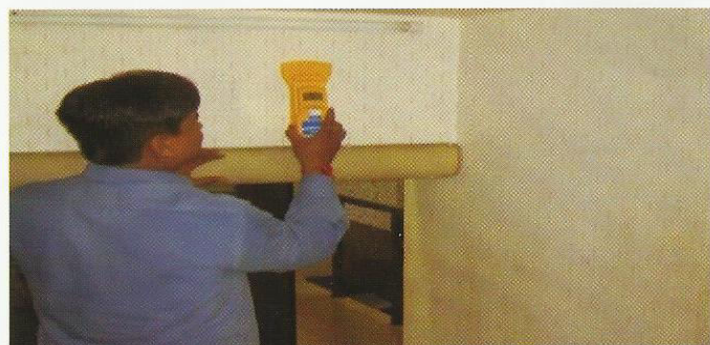
**Figure 6.** Moisture testing on wall for leakage detection

and delamination which gave lower UPV test results. Accordingly decision was taken to repair and strengthen those columns. A moisture meter survey (Figure 6) was carried out to locate the area of dampness and seepages for further waterproofing work. The basement was closed while the survey was conducted, and some parts of the structural members inside offices were covered by tiles or wall panels or false ceilings. The structures suffered more damage in areas that were not surveyed, which accounted for the major part of the estimated cost. This resulted in an overall increase in the budgeted amount. The amount allocated for structural glazing and aluminium composite panel work was re-allocated to the work on these hidden areas of restoration, as it was felt that health issues should be addressed before beautifying the building.

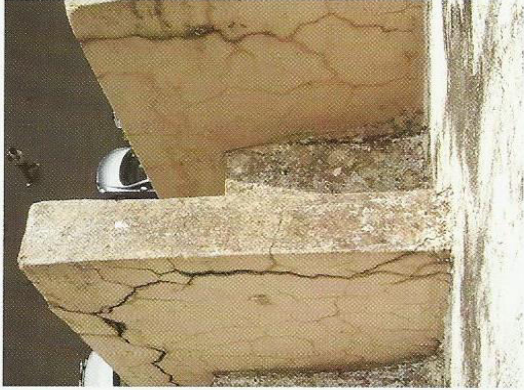
Figure 7. Elevation pardi before pardiess

It was suggested that the vertical fins (Figure 7), which were just for the purpose of elevation, should be removed completely to reduce the dead load and future maintenance cost. It took considerable time to break the RCC along with its reinforcement and to level the broken area as per the elevation design (Figure 8).

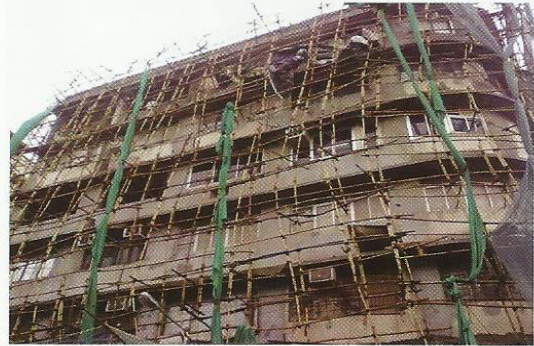
Figure 9. Continuous sunshade being provided

It was suggested that a continuous sunshade Figure 9 be constructed for protection against rainwater, instead of the old sunshades just over the window openings. This helps prevent water running over empty spaces along

the walls that results in the growing of moss and fungus, which causes the appearance of black spots and spoils the paint. All new re-bars were anchored to the beam with the help of FISCHER epoxy resin capsules and 100 mm thick reinforced concrete was cast uniformly with the help of waterproof ply shuttering.

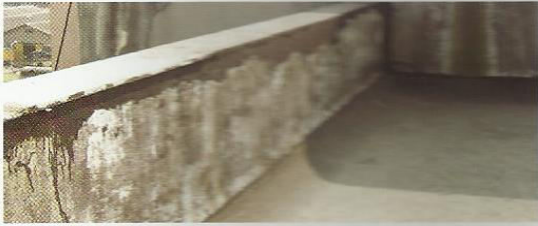
Figure 10. RCC coping before

a top finish of a 25 mm inward slope. Making shuttering on three sides has no complication because of the scaffolding support. The fourth side was also cast with additional safety measures. RCC coping before and after are shown in Figure 10 and Figure 11 respectively.

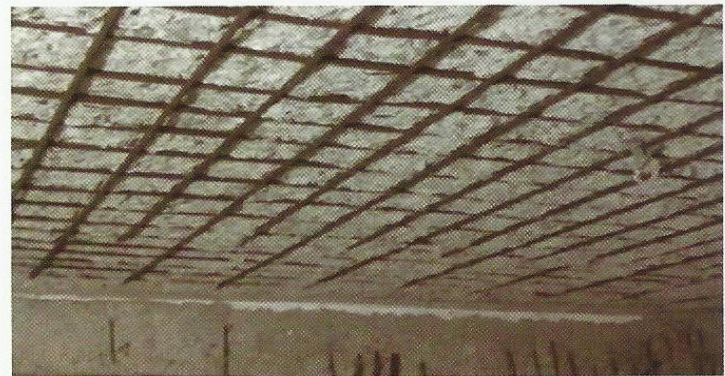
Figure 12. Roof slab before micro concreting

The beams and slabs in the basement were damaged Figure 12 due to leakage from the common WC block on the ground floor. A complete beam was jacketed in micro concrete by drilling a hole from the top floor. A portion of the slab bottom sagged and de-bonded. By providing watertight shuttering, slab casting was done using micro concrete with 6 mm down pea gravels poured from the top floor by making a few core cuttings for maximum flow up to 2 metres Figure 13. Similarly the damaged columns were strengthened were micro concreting. Figure 14 and Figure 15 show the column before micro concreting and column after micro concreting respectively.

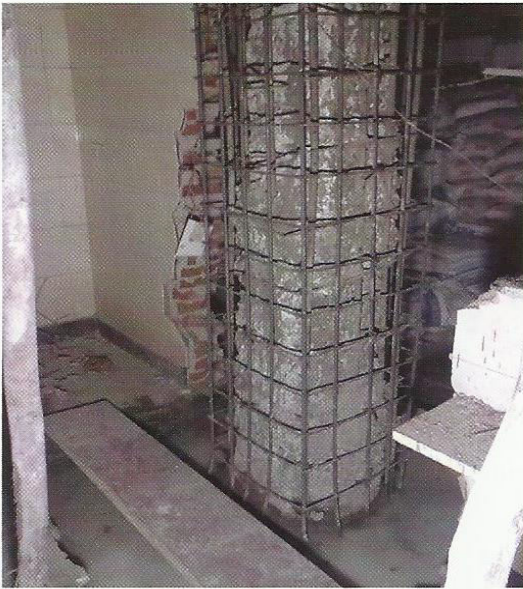
Figure 14. Column before micro concreting

25% of their original diameter volume, additional rebars were provided as replacement/ replenishment. Old and new bars were coated with a rust preventer, as a passivator coat. One or more coats were applied using a ready-to-use powder that was mixed with water and modified with powder polymers. The new reinforcement was connected to the original concrete by fixing Shear Connectors, using polyester resin anchor fix grouts. These connectors were fixed using a chemical based grout that has high pullout bond strength by drilling a hole into the concrete of a minimum of 100 - 150 mm in length. It was ensured that the pullout strength of that anchor was more than the tensile strength of the bar. After 24 hours, the entire surface was coated with a long pot life epoxy bond followed by a watertight shuttering, prepared to pour micro concrete.

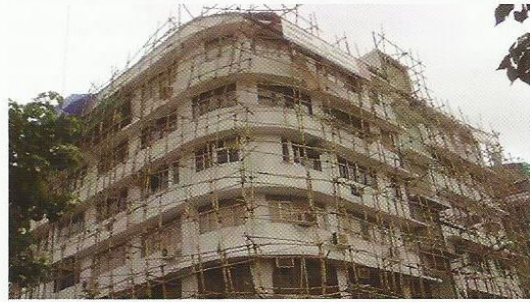
Figure 16. View after primer coat

The external surface of the building was protected again with good quality coating that had elastomeric properties. A hand roller was used for application instead of a brush. Three coats were applied with the hand roller as per manufacturer recommendations. Acrylic coating was used having crack bridging properties. This is very important for old buildings. A five year warranty against leakage was received and given to the client stating that the manufacturer will give free material during the tenure of the contract and the contractor will apply the material at no extra cost to the Society during the defect liability period. Such work will start within a week after a written intimation of complaint is submitted. The work will be done under supervision of the consultant till the defects

are rectified. Figure 16 and Figure 17 show the external treatment with primer and finished coat respectively.

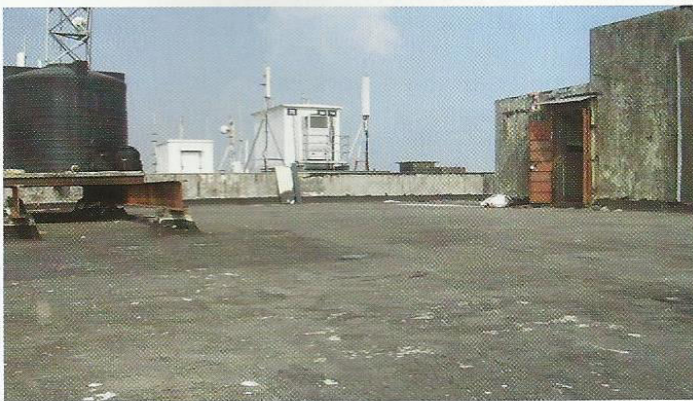
Figure 18. Before roof waterproofing

Looking at the condition of the top floor slab (Figure 18), it was impossible to remove the existing brick bat koba waterproofing. Also the imminent monsoon made it impossible to put new brick bat koba impossible, as the process is time consuming and the stacking of so much debris would not be easy. A decision was taken in favour of the non-destructive fast application method of bituminous hot application PP reinforced membrane. The APP (Atactic Polypropylene) membrane primer was fixed in a day, after application of bituminous primer on the entire roof on the previous night, and it was extended up to drip mould of parapet plaster. A rainwater outlet of an adequate size was made available to avoid water stagnation and the APP was extended to the inside of the rainwater pipe opening. APP laps were maintained uniformly and torched at softening point (Figure 19) to melt properly to avoid hiccups and make joints watertight. The parapet top was finished with sand face finish plaster and the top was covered with APP membrane for additional protection (Figure 20). The properties of APP membrane and the specification standard are given in Table 6.

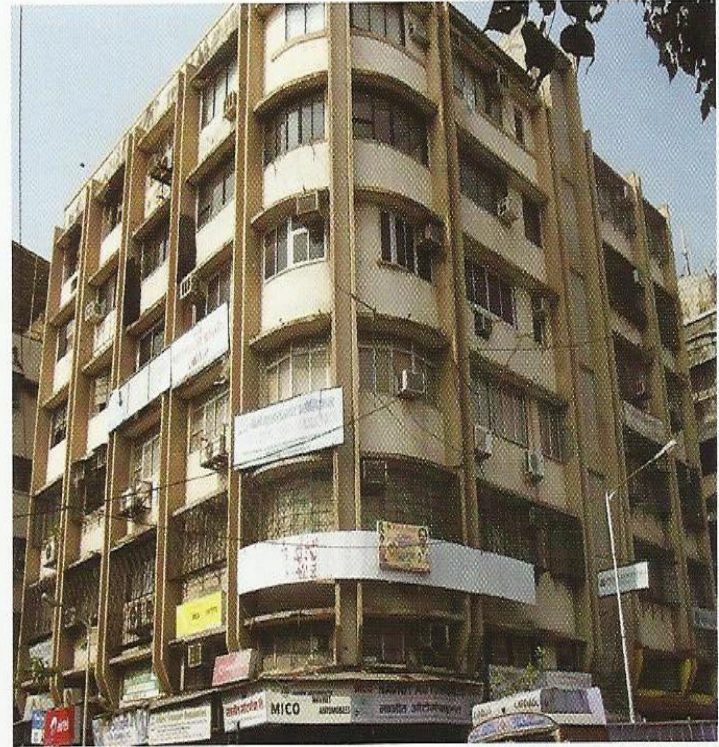
Figure 23. Elevation of the building before repair and rehabilitation

These types of structures need to be surveyed very carefully, if required sample portion may be opened to identify the condition of the core and level of corrosion. A survey must be conducted in all areas, especially enclosed / closed areas, by getting access when available. Extra time should be considered for difficult situations like working on platforms or over the footpath/public commuting areas. Execution can be performed well if owners clear the areas surrounding the structure in time and mutual cooperation is achieved between members to achieve long-term durability goals. However, with all those constraints, the repair and rehabilitation work of this project was completed satisfactorily. Figure 23 and Figure 24 show the elevation of the building before and after repair and restoration respectively.
